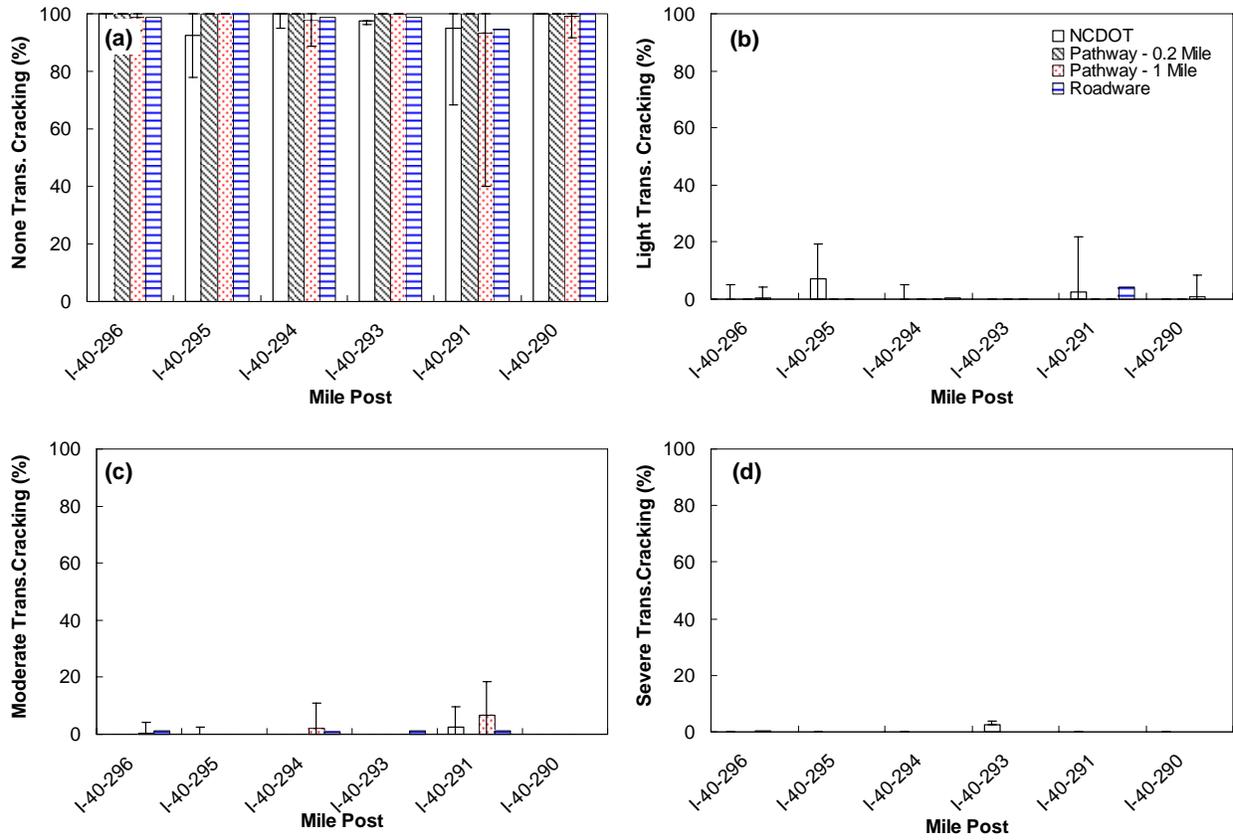
Figure 3.67. Transverse cracking for I-440/I-40 (2) sections; (a) none rating, (b) light rating, (c) moderate rating, and (d) severe rating.
